# Manhole Inspection Summary

Manhole # S21G\_\_053MH

Insp Date: **8/27/07 8:55 AM**

**Location** Address: **1953 FAYETTE-FAIRMOUNT**

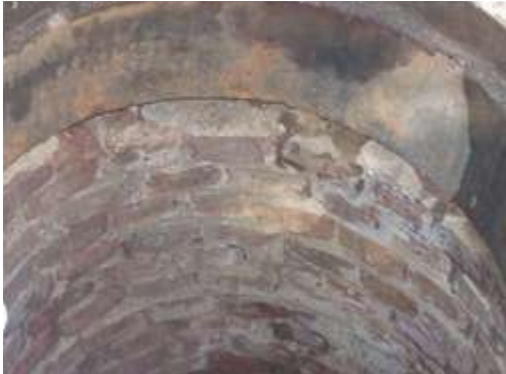
Defect 2

Condition: ☐ Sound ☐ Cracked ☐ Root Intrusion ☐ Loose Brick ☒ **Deteriorated**

CORBEL DETERIORATION

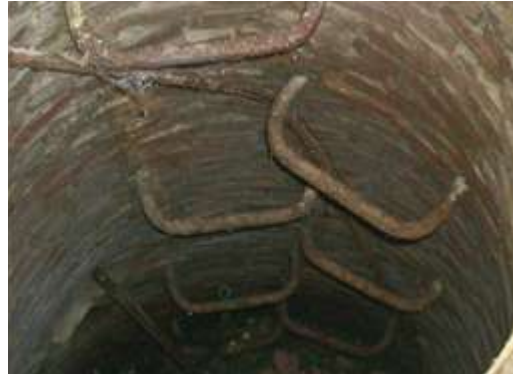
Defect 1

Count: **7** Missing: **0** ☒ **Corroded**

CORRODED STEPS

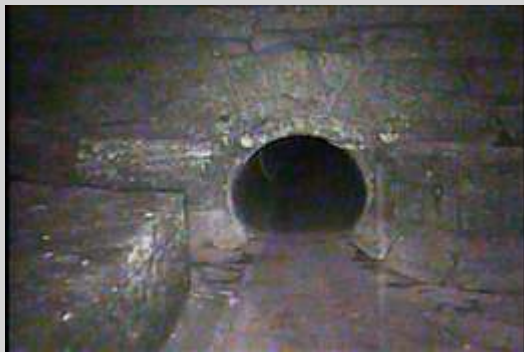
12 O'Clock Outflow

Pipe Height: **8.4** (in.) Rod and Bar (Angled)  
Pipe Material: **Clay** ☐ Pipe Lined  
Invert Depth: **12.08** (ft.) Flow Characteristics: **Slow**  
Deposits: ☒ None ☐ Mud ☐ Sludge ☐ Debris ☐ Grease  
Silt Depth: (in.) Deposits Extent:  
Infiltration: **None** Pipe Seal Cond: **Sound**

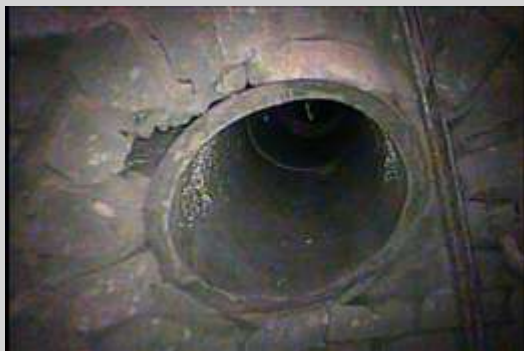
3 O'Clock Inflow

CORRODED STEPS

Pipe Height: **8.4** (in.) Rod and Bar (Angled)  
Pipe Material: **Clay** ☐ Pipe Lined  
Invert Depth: **7.03** (ft.) Flow Characteristics: **Slow**  
Deposits: ☒ None ☐ Mud ☐ Sludge ☐ Debris ☐ Grease  
Silt Depth: (in.) Deposits Extent:  
Infiltration: **None** Pipe Seal Cond: **Cracked**

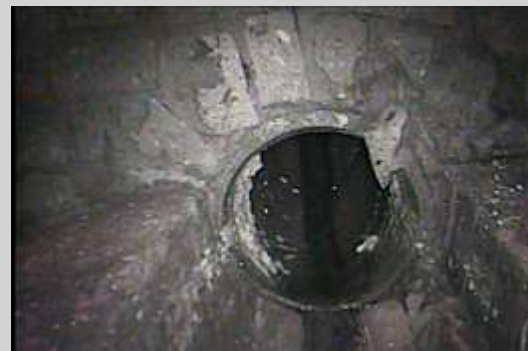
Drop In @ 3 O'Clock

CORRODED STEPS

Drop: **Outside** Rod and Bar  
Angled: **Yes** Reading: **10.42** (ft.)  
Inv Depth: **11.42** (ft.)  
Drop Condition: **Open**

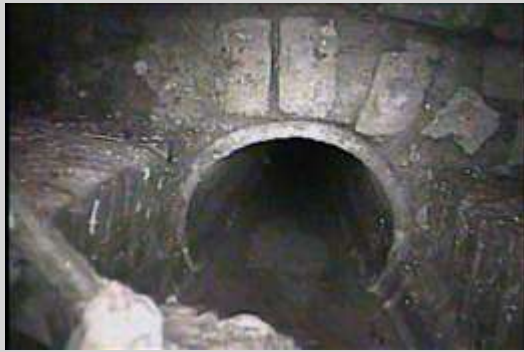
6 O'Clock Inflow

Invert Depth: **11.87** (ft.) Flow Characteristics: **Slow**

Infiltration: **None** Pipe Seal Cond: **Sound**

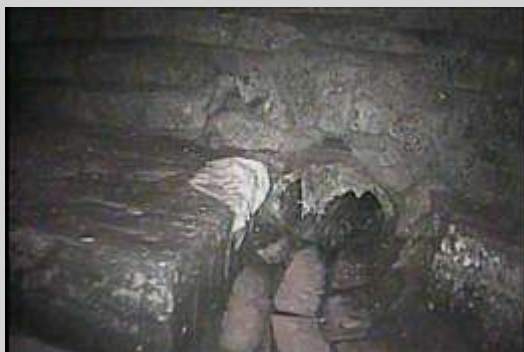
9 O'Clock Inflow

Invert Depth: **11.88** (ft.) Flow Characteristics: **None**

Infiltration: **None** Pipe Seal Cond: **Sound**
